**Docket No. 217 – Development and Management Plan Inspection**

Northeast Utilities Service Company Certificate of Environmental Compatibility and Public Need for the construction of a 345-kV electric transmission line and reconstruction of an existing 115-kV electric transmission line between Connecticut Light and Power Company's Plumtree Substation in Bethel, through the towns of Redding, Weston, and Wilton, and to the Norwalk Substation in Norwalk, Connecticut.

**Date:** September 1, 2005

**Location:** 115 kV Underground Route

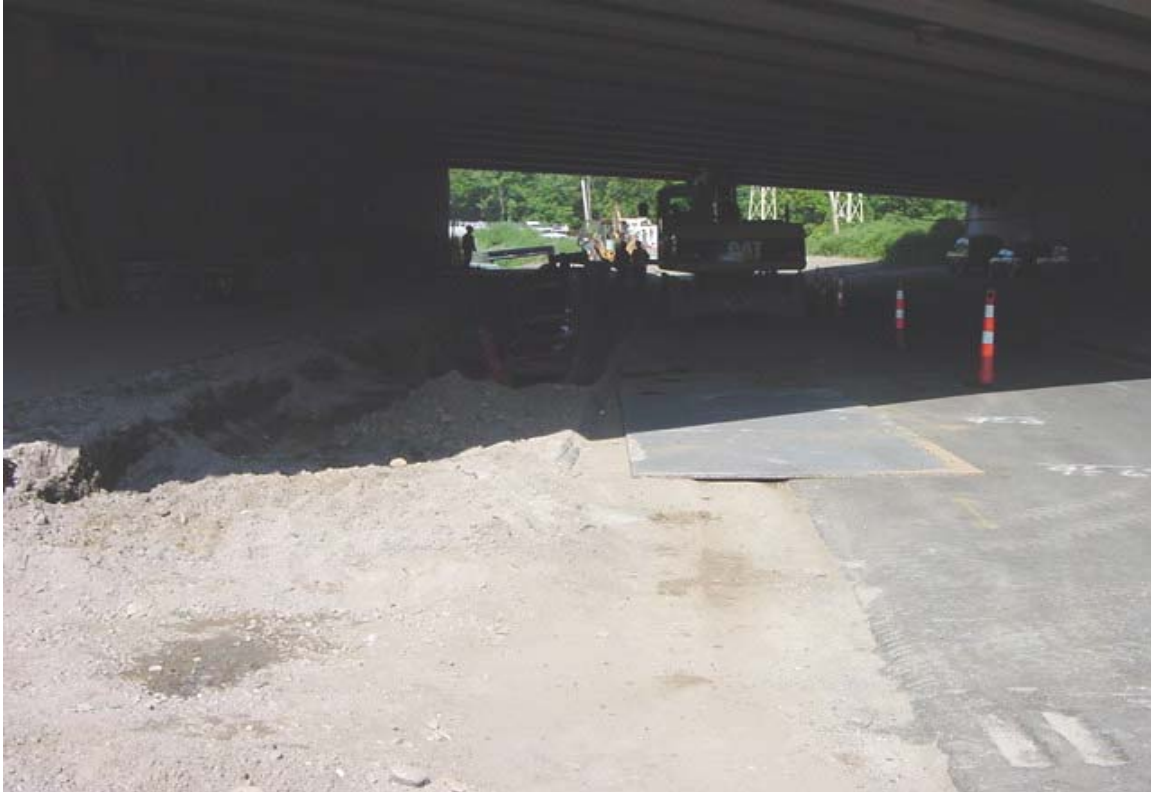
115 kV (Broad Street): Work on the vault near the overpass is underway. 9/1/05

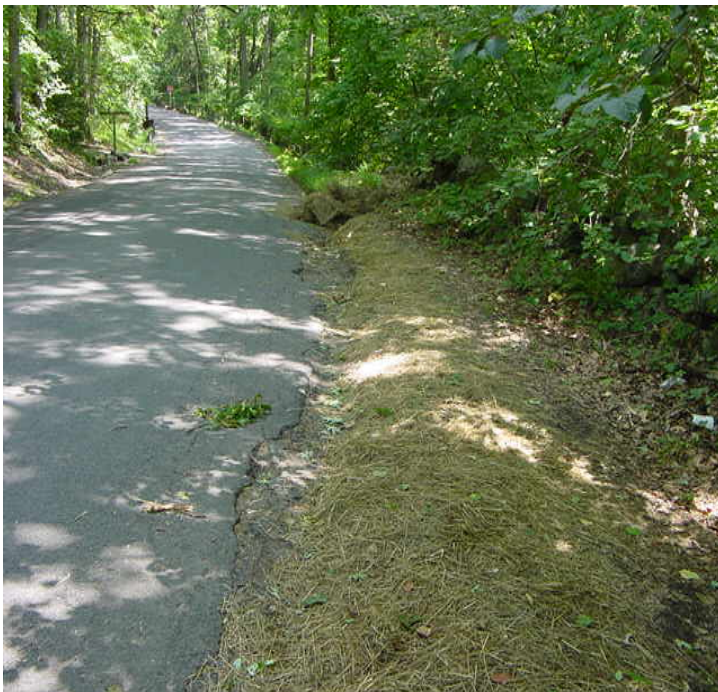
115 kV (Gallows Hill Road): Photo on the left shows the area near #124 where mulch was placed to help stabilize the area. Photo on the right shows where haybale check dams were added near #116. 9/1/05

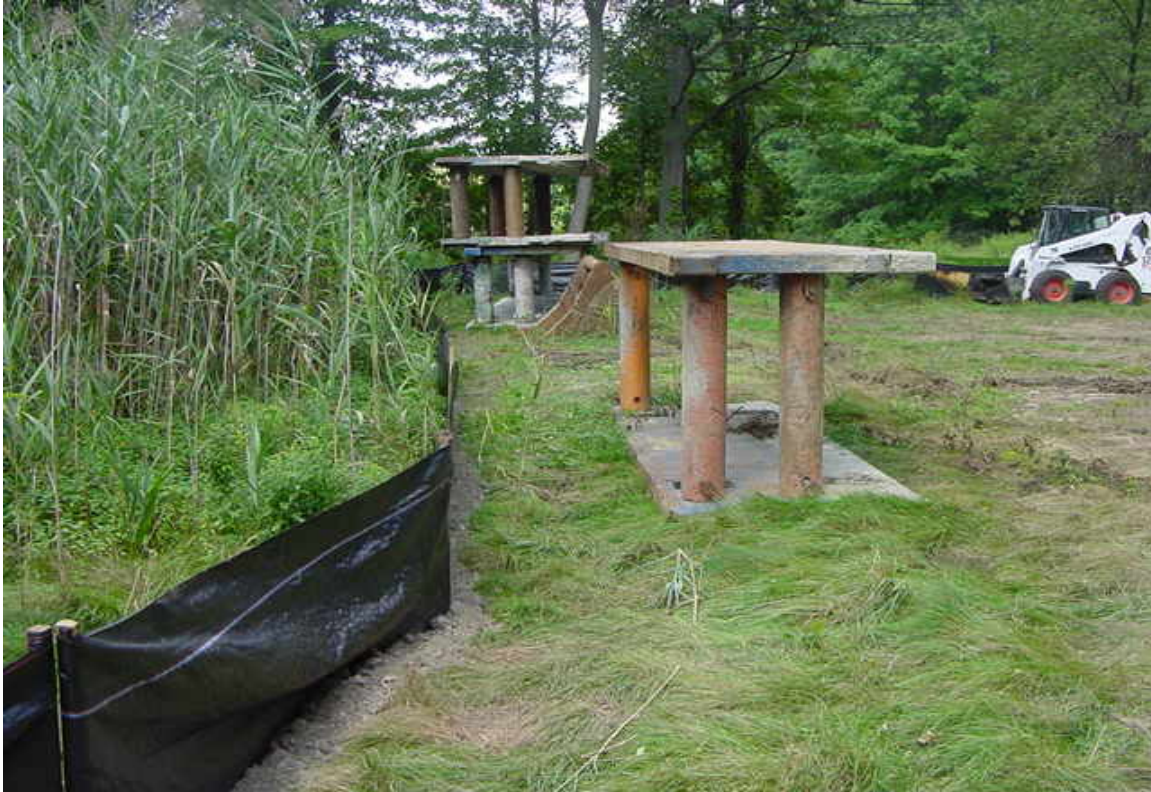
115 kV (Rt. 107): View of a new storage area identified near the Redding Country Club. The RCC has give permission to the project to use this area. 9/1/05

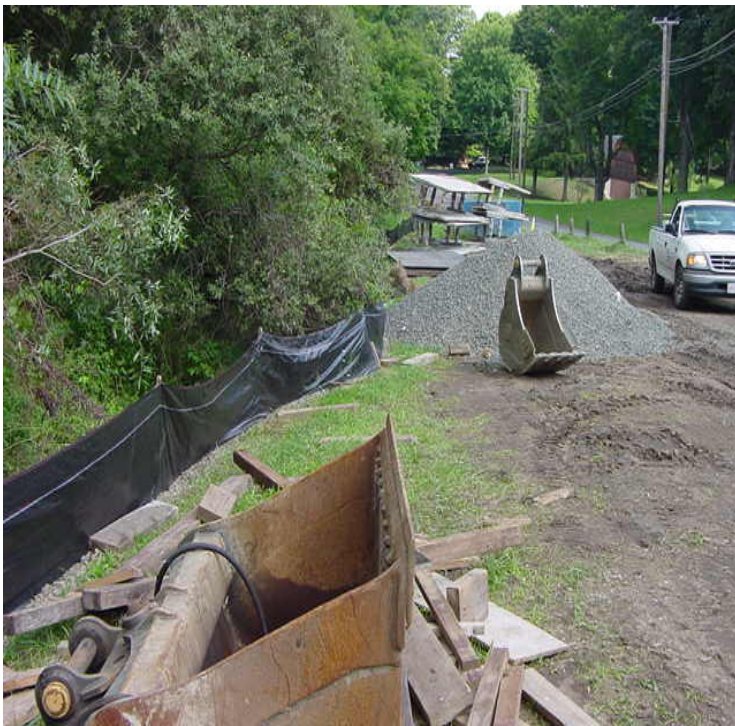
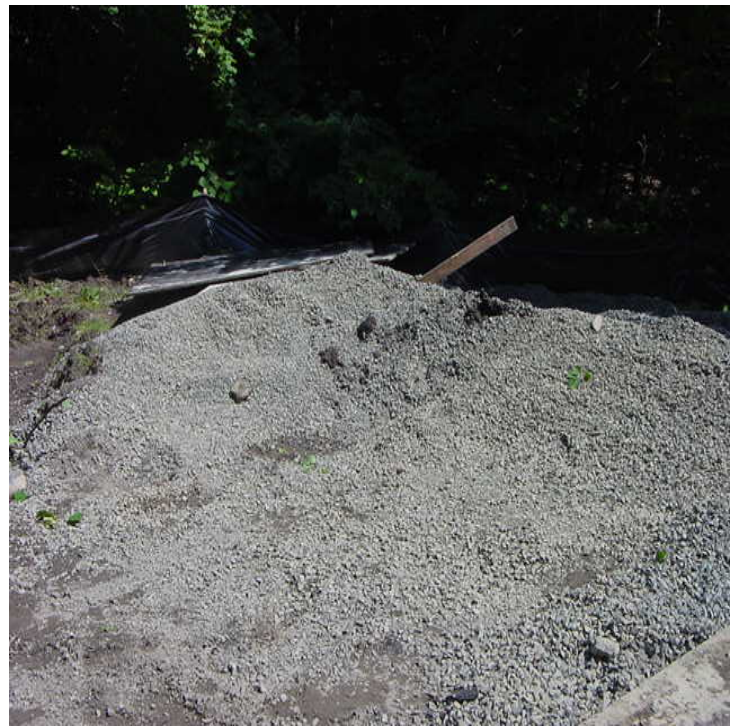
115kV (Rt. 58): View of the storage area near the Putnam Park entrance. Materials/equipment were placed up against the fence and should be pulled back. 9/1/05

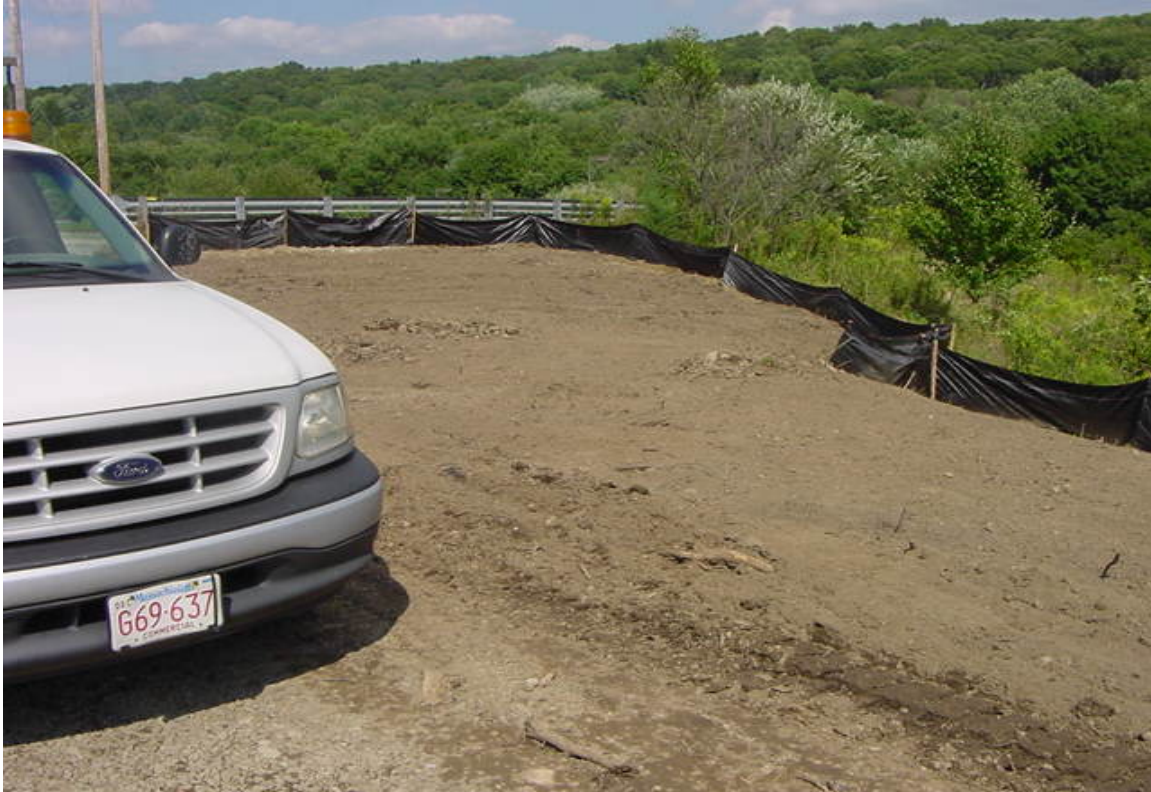
**115kV (Bethel Education Park): The stockpiles have been removed from the ROW and the silt fence has been repaired. 9/1/05**

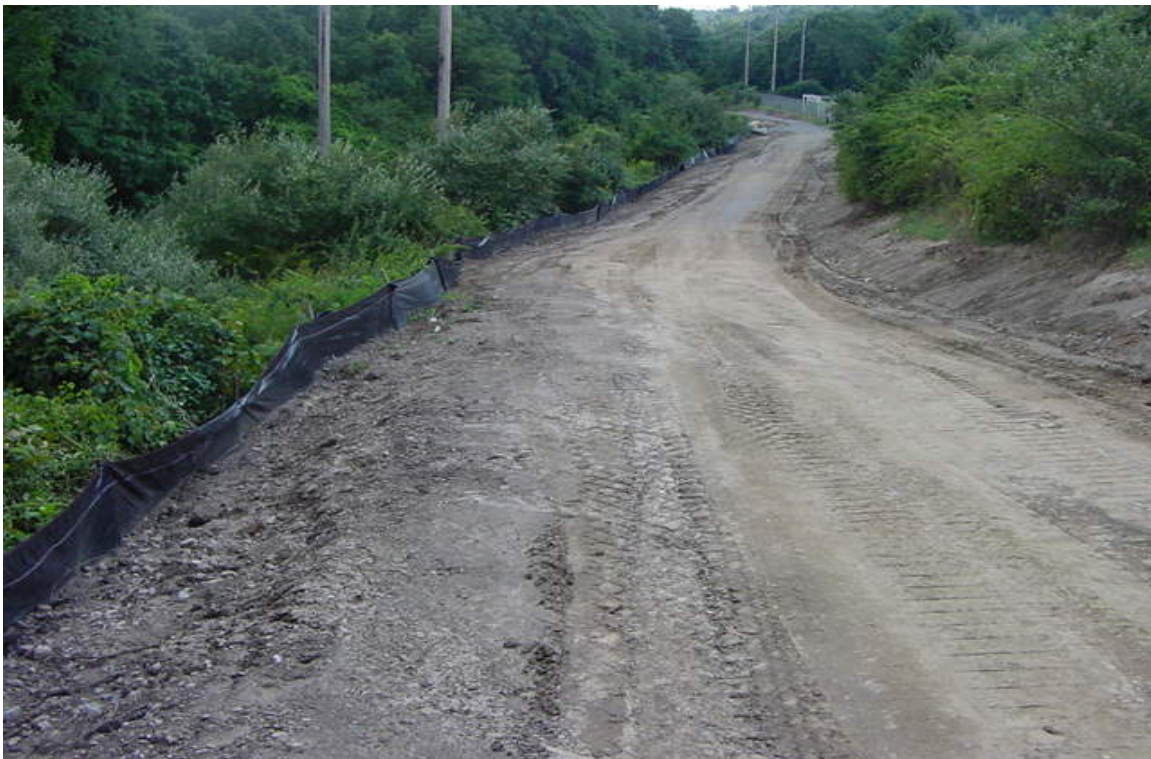
**View along the southern portion of the ROW where all the silt fence has been restored and is in good shape. The ROW should be seeded if not already done so. 9/1/05**

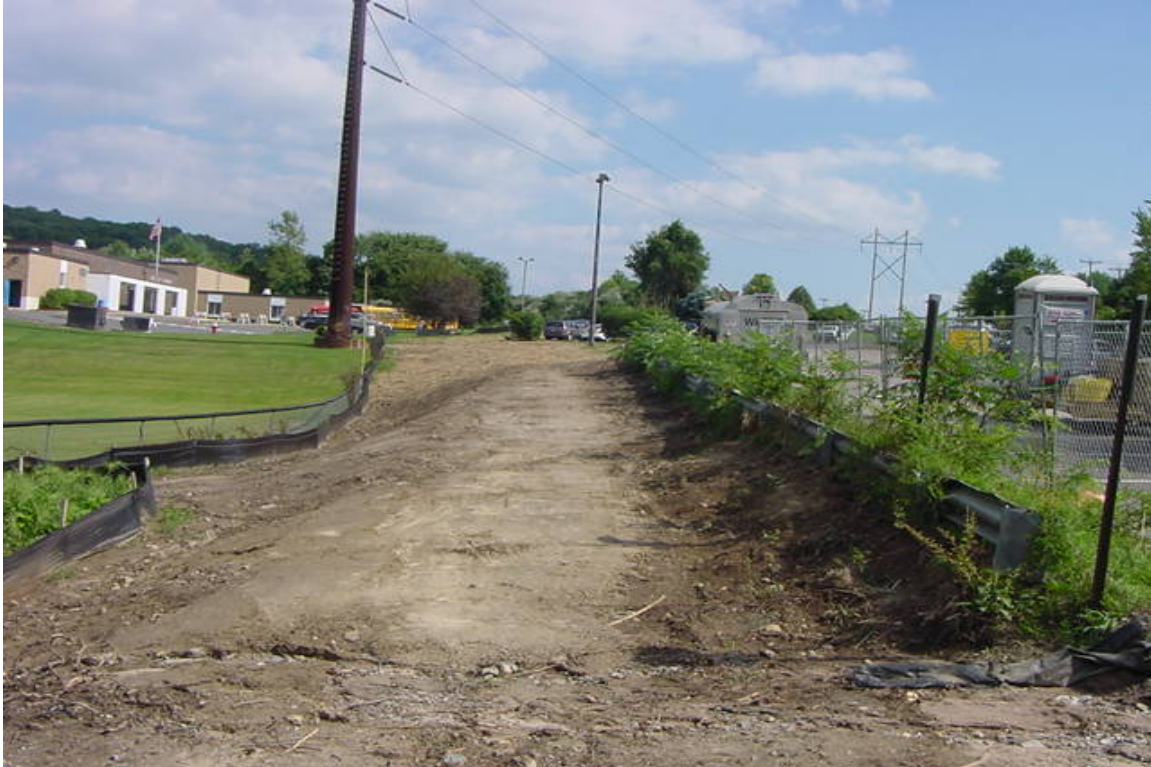
**View of the northern portion of the ROW where the silt fence is also in good shape. The ROW should be seeded if not already done so. 9/1/05**

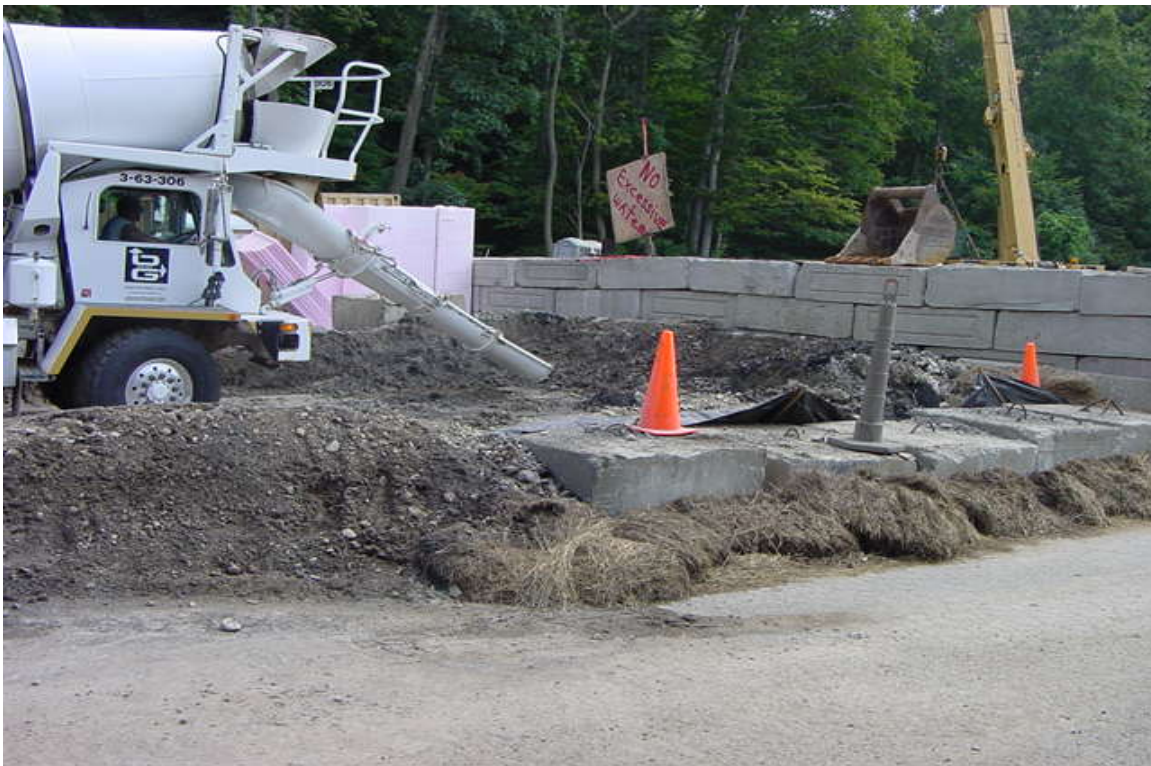
**115kV (Redding Town Yard): View of a concrete truck actively using the concrete washout area in the yard. 9/1/05**

Areas of Inspection	Observation	Recommended Action
Spills and Material Storage	<ul style="list-style-type: none"> <li>- Better controls were needed at the concrete washout area for Rt. 7 nightwork. This should be investigated and confirmed if improvements were made. 9/1/05</li> <li>- A report of any leaks or spills that reach the ground and occur during the week should be provided to BSC from internal project inspectors 6/15-9/1/05</li> <li>- In general catch basins, inlets and swales should continue to consistently be protected especially in any area with sawcutting activities. 9/1/05</li> </ul>	<ul style="list-style-type: none"> <li>-Continue to make sure concrete washouts are restricted to designated areas. 9/1/05</li> <li>- Continue to keep all vehicles maintained well (i.e. no apparent fluid leaks) if they will be used or stored on site. Check equipment status on a regular basis and keep spill kits on hand. Report spills immediately, even if they are being controlled.</li> <li>- The contractors should remain vigilant about securing and handling fuel and material containers.</li> <li>- Equipment and materials should not be stored in wooded areas unless it is designated for storage.</li> </ul>
